Contract #: 04-0120F4

# WELDING INSPECTION REPORT

OSM Arrival Time: 800 **Project Name:** SAS Superstructure **OSM Departure Time:** 1800 **Prime Contractor:** American Bridge/Fluor Enterprises, a JV

34-0006 **Bridge No: Component:** Tower, Deviation and Jacking Saddles

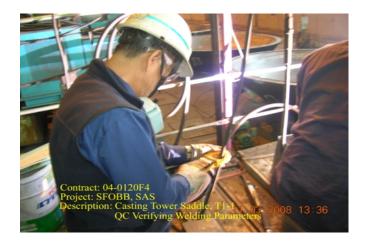
At the start of the shift the QA inspector traveled to the shop to observed the scheduled work performed on the casting stem and rib on the Tower Saddle identified as T1-1. The weld build-up was performed on the casting stem and rib which were identified as 7Y-8U utilizing the Welding Procedure Specification (WPS) SJ-3012-1-1. The WPS was also used by the Intertek Testing Service (ITS) Quality Control (QC) Inspector Chung Fu-Kuan as a reference during QC verification of the Alternating Current (AC) welding parameters. The SMAW process was performed by JSW welding personnel Takatoshi Inowe ID 08-5163 with the tower saddle positioned so that the performance of the welding was in the flat position with the work in the horizontal plane and the weld metal deposited from above.

The following digital photographs illustrate the observations of the activities performed on this date.
